Debris/Ice/TPS Assessment And Photographic Analysis For Shuttle Mission STS-48

November 1991

Gregory N. Katnik
NASA/Kennedy Space Center

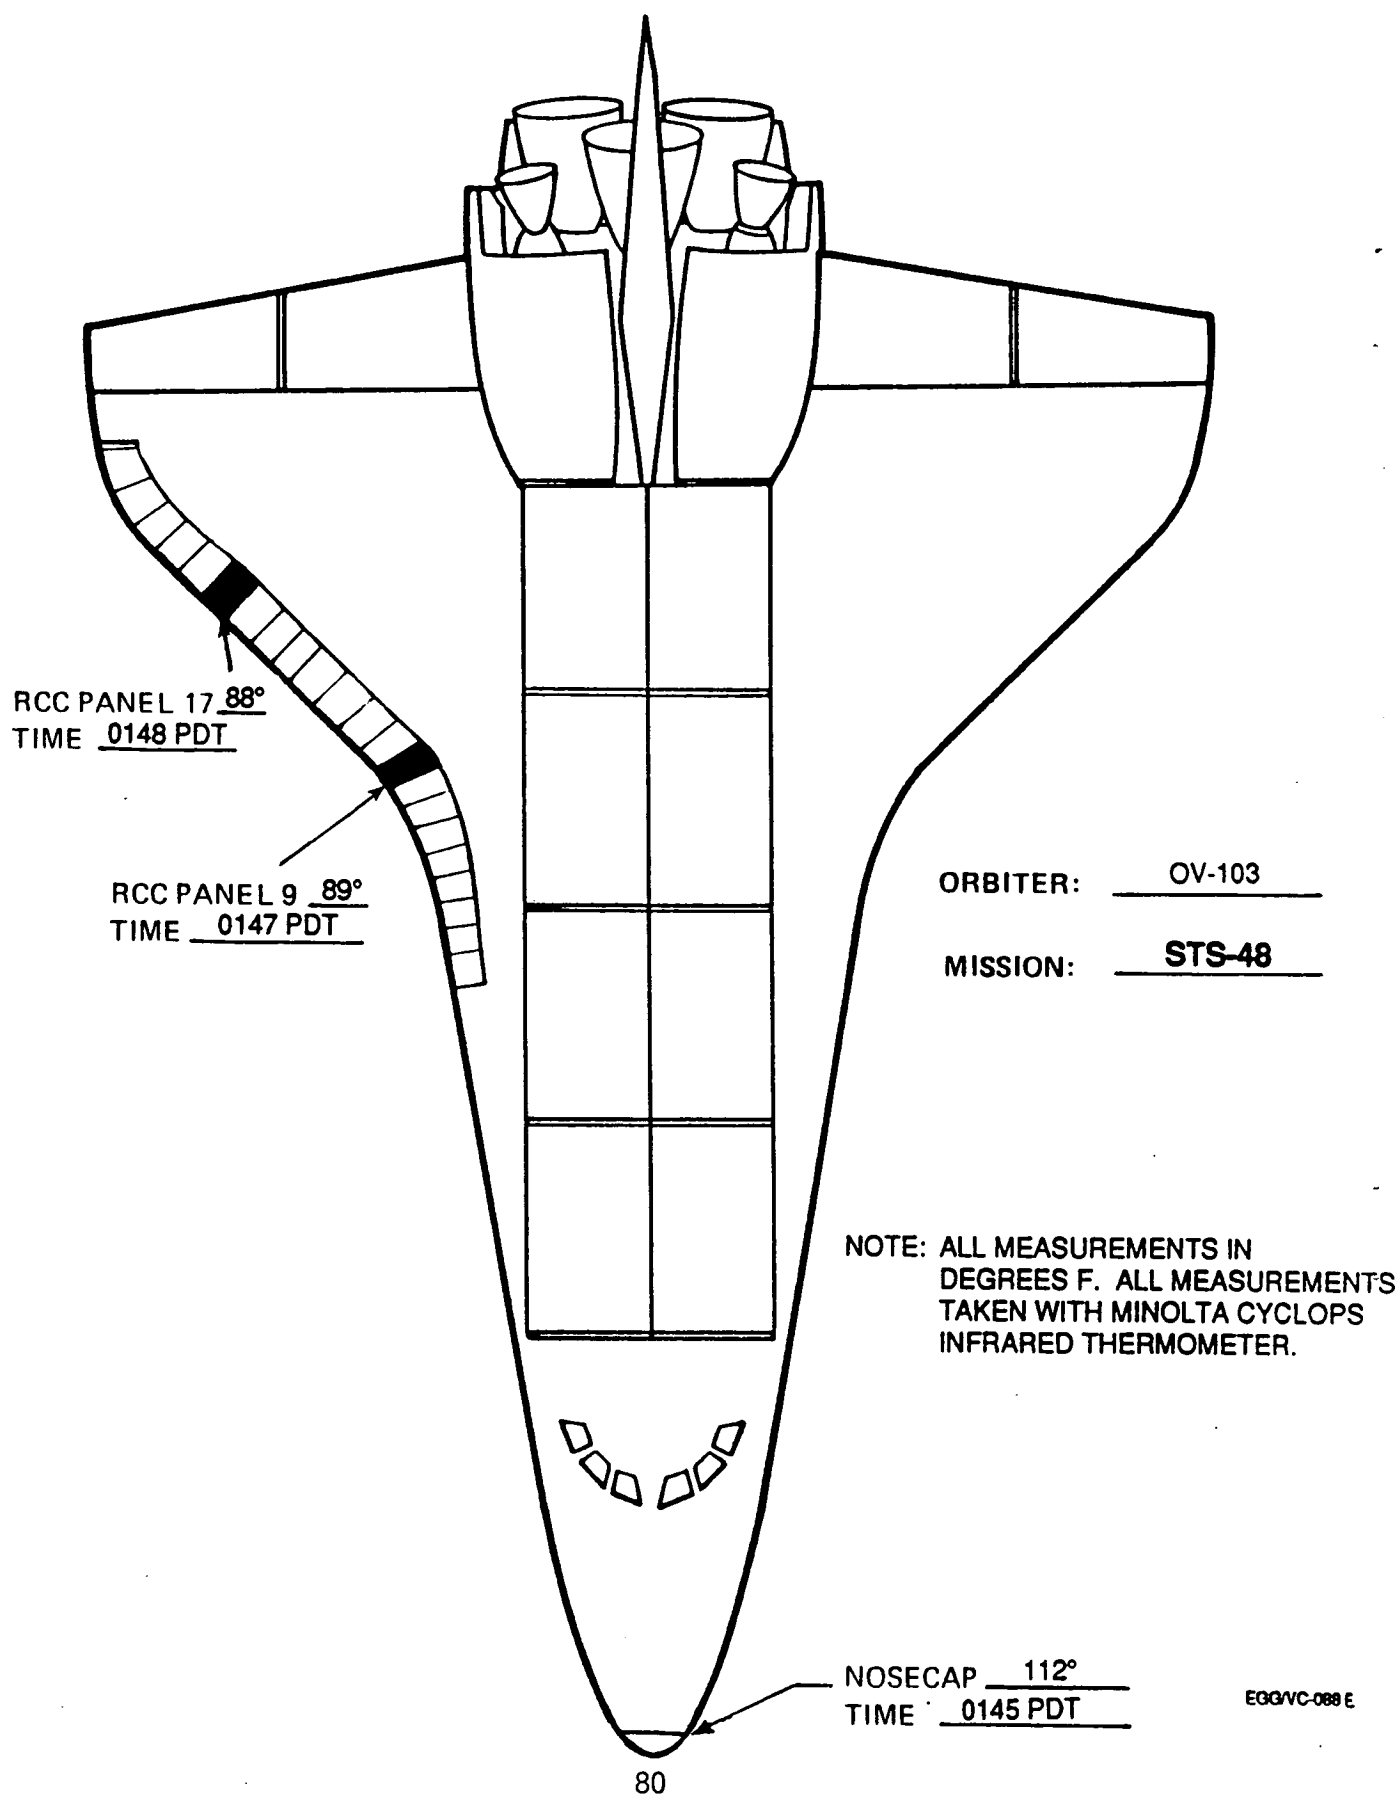
FIGURE 16. **STS-48 RCC TEMPERATURE MEASUREMENTS**

A portable infrared thermometer was used to measure the surface temperatures of three areas on the Orbiter TPS after landing (OMRSD V09AJ0.095). Seventy minutes after wheel stop, the Orbiter nose cap RCC was 112 degrees F, the RH wing leading edge RCC panel #9 was 89 degrees F, and the RH wing leading edge RCC panel #17 was 88 degrees Fahrenheit (reference Figure 16).
